# Manhole Inspection Summary

Manhole # S47K\_\_006MH

Insp Date: **4/2/08 11:10 AM**

**Location** Address: **2317 S Bradford St**

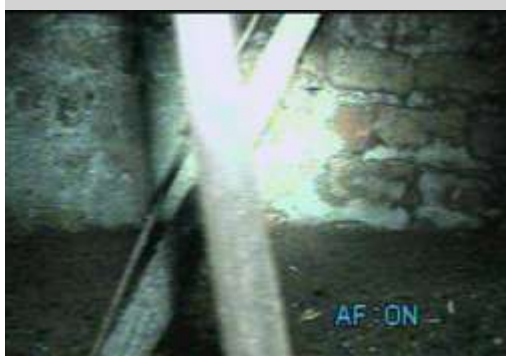
Defect 2

Condition: ☐ Sound ☐ Cracked ☐ Root Intrusion ☐ Deteriorated ☐ Leaks ☒ **Debris**

channel debris

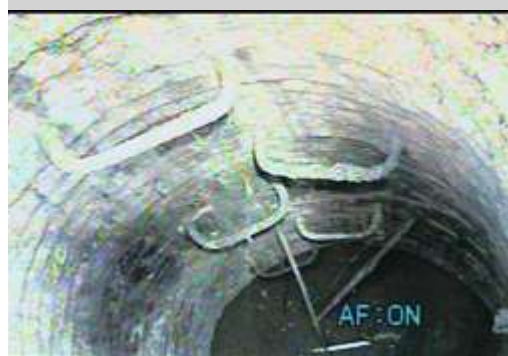
Defect 1

Count: **5** Missing: **0** ☒ **Corroded**

corroded stairs

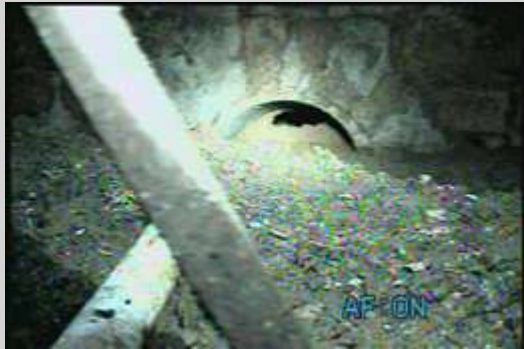
12 O'Clock Outflow

8 in. Circular Gravity Sewer  
Pipe Out @ 12 O'Clock

Deposits: ☐ None ☐ Mud ☐ Sludge ☒ **Debris** ☐ Grease

Silt Depth: **5** (in.) Deposits Extent: **Heavy**
